# ION THRUSTER SYSTEM (8-CM) CYCLIC ENDURANCE TEST

C.R. Dulgeroff, J.R. Beattie, R.L. Poeschel, and J. Hyman, Jr.

Hughes Research Laboratories  
3011 Malibu Canyon Road  
Malibu, CA 90265

Final Report

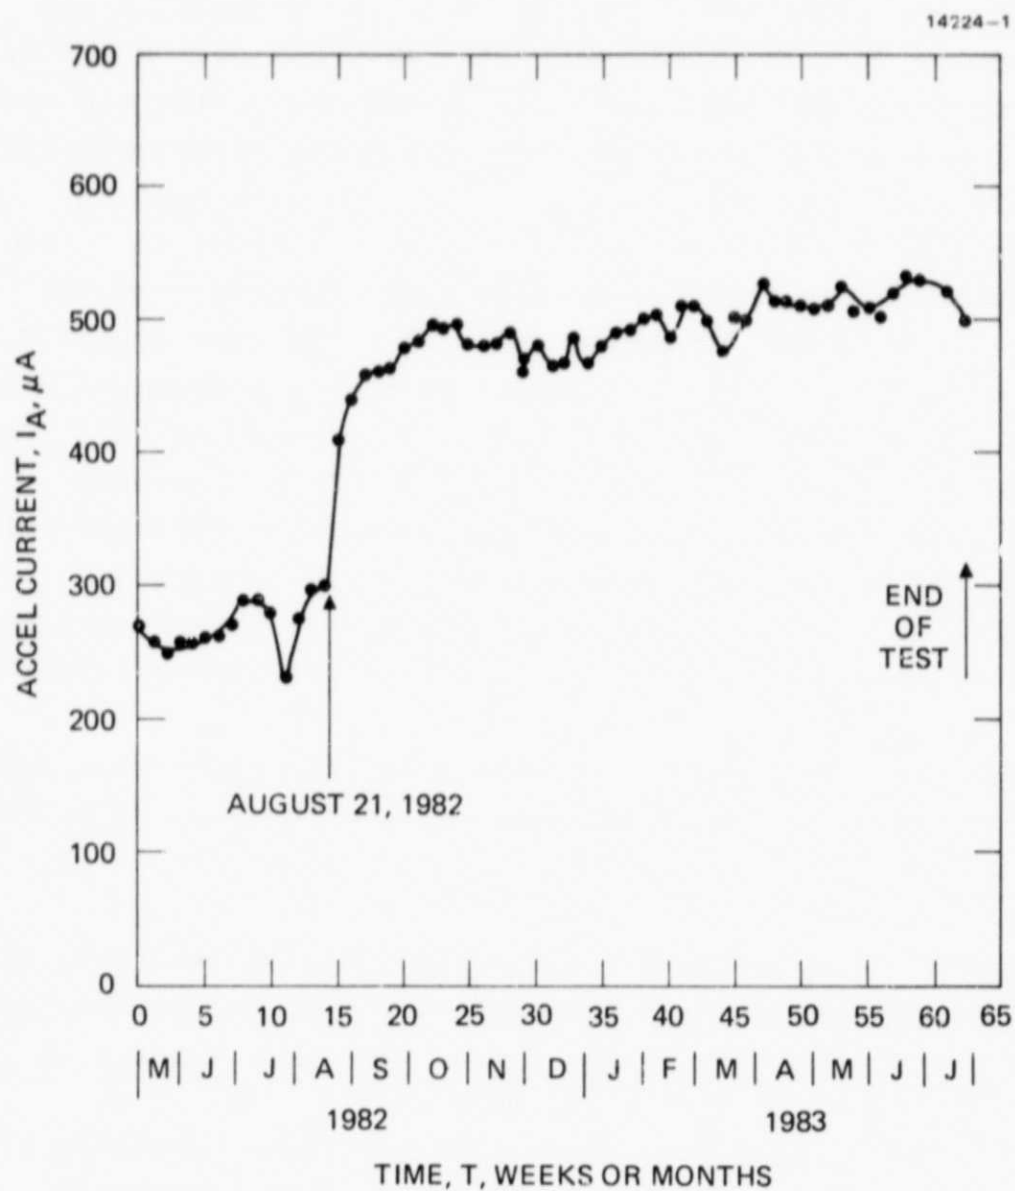
Figure 11. Accel current,  $I_A$ , as a function of cyclic test time.

An increase in accel current (mentioned earlier) which followed one of the vaporizer-runaway events is noted in Table 3 for August/1982. The variation in coupling voltage that is evident in Table 3 is associated with the neutralizer variations. A total of 436 automatic recycles occurred, with the majority taking place early in the test; the recycle count rate changed after August 21, 1982. There was about a 2% variation in thruster power throughout the test.

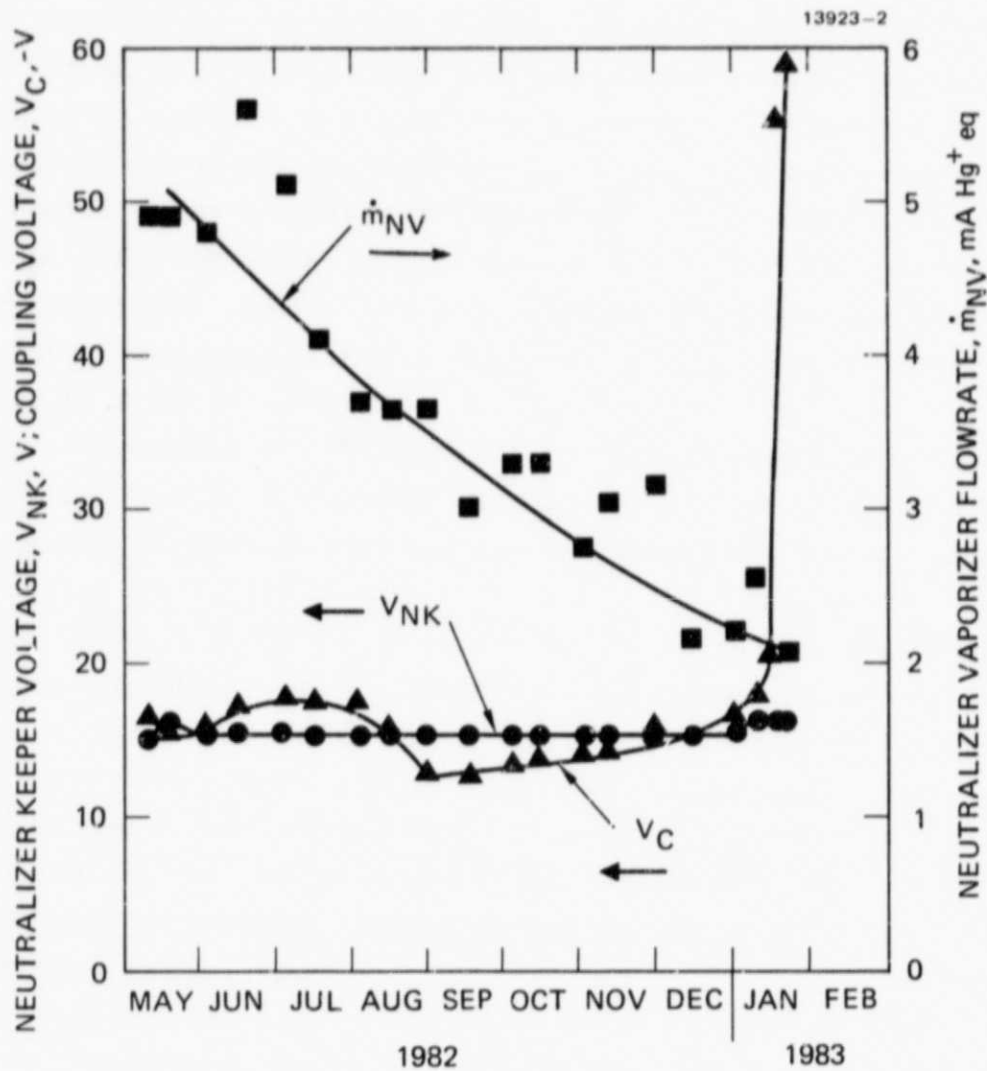
Figure 12. Neutralizer-keeper voltage,  $V_{NK}$ , coupling voltage,  $V_C$ , and neutralizer-vaporizer flowrate,  $\dot{m}_{NV}$ , as a function of time.

After December 1982, the coupling voltage could not be kept below 30 V with a keeper voltage of less than 16 V; to correct this condition, two changes were made. The first was to increase the neutralizer-keeper current and the second was to increase the neutralizer cathode power. Increasing the neutralizer-keeper current caused the accel current to increase and become noisy; increasing the neutralizer-tip heater power from 4.9 W to 8.1 W brought the coupling voltage to below 30 V. This improvement in coupling voltage was short-lived however. The next change was to decrease the mercury-vapor flowrate. This change also brought about a short-time decrease in coupling voltage. Throughout these changes, maintaining stable operation of the neutralizer after start-up became a problem and many neutralizer extinctions occurred before a stable condition was established. The coupling voltage was finally restored to  $V_C \approx -30$  V by maintaining 4.9-W of tip heat to the cathode, and increasing the neutralizer-vaporizer flowrate to about 7 mA (equivalent). This flowrate value was achieved by maintaining keeper reference voltage at 10 V (approximately 5 V below its value early in the test). Also, although the flowrate was nearly the same as it was at the start of the test, the coupling voltage was higher. Post-test examination revealed that the neutralizer-cathode-orifice diameter had increased, and the keeper aperture diameter had decreased from their nominal values. This explained the poorer coupling characteristics. The reason that the sputtering occurred is attributed to operation of the neutralizer at what was later realized to be a very low ( $\approx 2-4$  mA) value of mercury flowrate.<sup>4</sup>

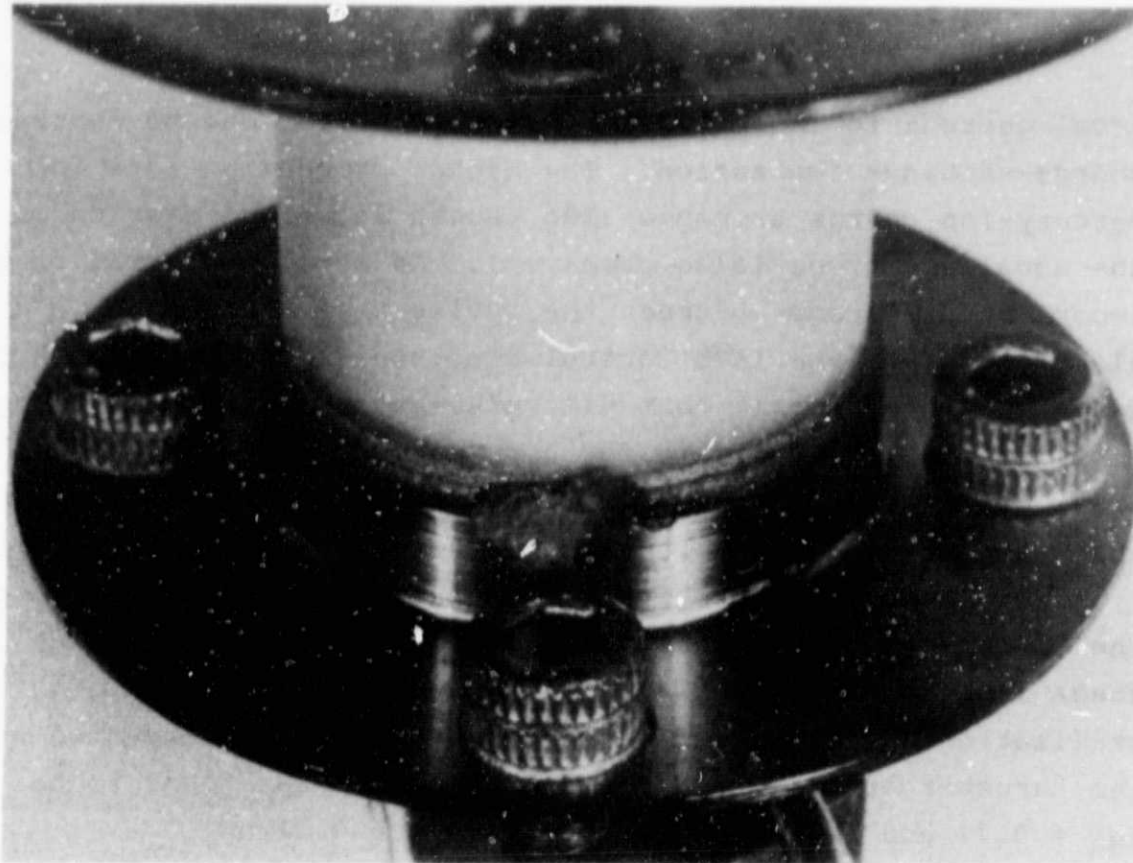
Since the ionization-gage pressure-test results pointed toward a faulty isolator, the CIV was removed from the thruster and its shield was removed. Figure 16 shows part of the upstream braze joint between the ceramic isolator housing and metal flange. The ball of material which is visible has a granular, copper-colored appearance. Except for this, the rest of this braze joint looked normal. Approximately 1.3 cm of the downstream braze joint had material of the same appearance but in lesser volume. The assembly was pressurized internally to about 7 psi ( $4.8 \times 10^4$  Pa) of argon and a leak was detected at the ball of material shown in Figure 16. The material on the downstream braze at first appeared not to leak at this pressure; but, after sealing the upstream leak, the downstream joint was found to leak when checked with a leak detector.

Figure. 16. Braze joint of isolator to flange.

This type of copper-braze failure has never been observed on 5-cm or 8-cm thrusters. This leads one to believe that the isolator on the cyclic life test thruster had experienced an extremely abnormal environment. We know that both vaporizers were operated at full power on four occasions for periods between 11 and 16 hours without a thruster discharge because of a deficiency in the ground-test equipment. Furthermore, the accel current increased following one of these excursions early in the test. One can postulate that mercury condensed in the isolator and that liquid mercury contacted the braze joints during these events and subsequently amalgamated with the copper braze to form the material observed on the joints. A leak developed in the braze and thereby reduced the propellant utilization. The only paths out of the thruster from the isolator leak are around the neutralizer keeper and via the lip of the ground-screen mask which leads either through the interelectrode region or downstream of the accel electrode. The higher vapor density in this region apparently caused the

accel current to increase (which was observed) due to increased charge-exchange ionization. The higher production rate for mercury-ion charge exchange also caused increased erosion of the accel electrode (also observed). As mentioned earlier, an important difference between the cyclic-test control electronics and the IAPS control electronics is that the IAPS has a software program that will prevent the full power being supplied to the vaporizers for long periods of time. Hence, we are confident that the IAPS will never be exposed to the events that caused the leak in the isolator described above.

The leaks in the isolator were sealed with an epoxy, and the CIV assembly passed a helium leak test. To assure that these leaks were the cause of the lower total mercury utilization and higher accel current, a test was conducted with the thruster at  $V_\delta = 27$  V. The utilization was found to be  $\eta_{Hg} = 0.77$  and the accel current was  $I_A = 0.21$  mA. These values are very close to the pre-test acceptance test values of  $\eta_{Hg} = 0.78$  and  $I_A = 0.23$  mA. This result is important because it demonstrates that the thruster performance did not change significantly after approximately 10,000 hours of "beam-on-time".

The mercury-vapor leak that developed in the cathode-isolator braze material is attributed to insufficient automation of the ground-support equipment at the beginning of the test that led to condensation of mercury within the isolator. Flight software such as that developed for the IAPS can control the power electronics to prevent the condition that led to condensation of mercury in the isolators preventing long periods of full power being supplied to either vaporizer. Appropriate interlocks for ground-support equipment were also successful in preventing the condition during the majority of the life test period.

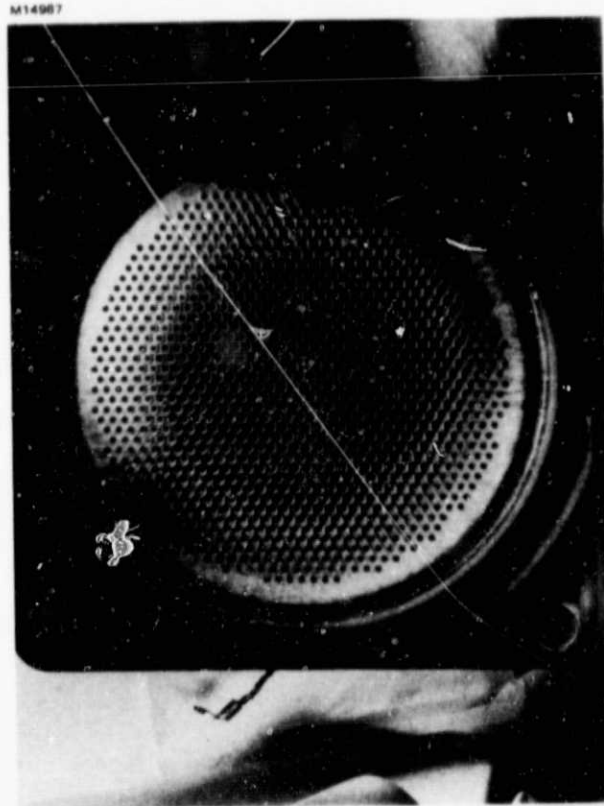
The major wear on the electrode assembly occurred in the accelerator grid. There are two sets of hole diameters in the accel grid. The centrally located holes had diameters of 0.045 in. (0.114 cm) at the start of the test, and they increased to a range of 0.046-to-0.050 in. (0.117 cm to 0.127 cm) in diameter. The outer holes had diameters of 0.033 in. (0.084 cm) at the start of the test, and they increased to 0.034 in. (0.086 cm) in diameter; the small holes near the edge had become non-circular. The post-test accel grid is shown in Figure 17. This increase in hole size decreases the

This abnormally high erosion rate was brought about by two abnormal conditions: (1) operation at  $V_0 = 25$  V, and (2) the passage of leaking mercury vapor across the downstream surface of the accel grid. These two abnormal conditions should not exist on the IAPS flight.

Figure 17. Post-test appearance of the accelerator grid.

- (1) A value of  $V_\delta = 26.5$  V will be used instead of the value  $V_\delta = 25$  V used inadvertently in the cyclic endurance test.
- (2) The leak-tight IAPS isolator will eliminate the cause of a supplementary supply of mercury vapor which was delivered to the charge-exchange ion-production volume during the cyclic test.

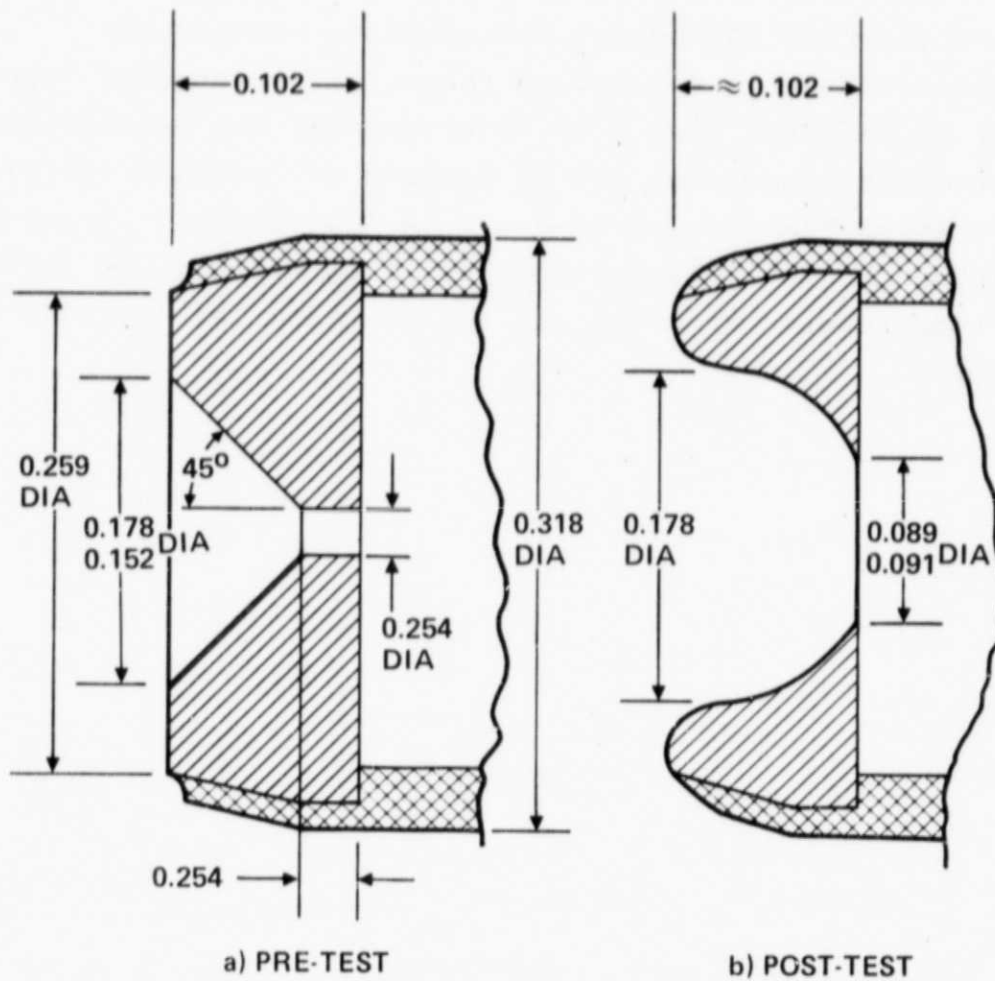
The neutralizer keeper was removed from the assembly and measurements were made of the cathode tip. The hole in the tip had increased from a 0.010-in. (0.025-cm)-diameter hole to about 0.035 in. (0.089 cm). Sharp edges were rounded off and the 45° countersink in the tip showed severe erosion (Figure 18). There are three possible causes for the neutralizer-tip erosion. One cause is that the neutralizer was operating at abnormally low flowrates.<sup>4</sup> Another is the higher-than-normal mercury vapor (from the isolator leak) around the neutralizer keeper. This would permit more mercury ions to be generated around the keeper hole, and some of these ions could strike the neutralizer cathode. The last possible cause is related to a high coupling voltage. Since the neutralizer cathode itself is at the coupling-voltage potential (neutralizer common), any ions near the neutralizer keeper and at ground potential would strike the cathode with more energy as the coupling voltage increases. Sixty percent of test time the coupling voltage remained constant near  $V_C \approx -15$  V; however, the rest of the time the magnitude of the coupling voltage increased to a value of  $V_C \approx -30$  V. The erosion of the cathode tip is the result of a combination of these three causes.

The material eroded from the tip had apparently deposited on the circumference of the keeper hole, decreasing its diameter from 0.070 in. (0.178 cm) to 0.056 in. (0.143 cm). We know (from previous studies<sup>5</sup>) that the neutralizer coupling may become degraded for keeper holes smaller than 0.070 in. (0.178 cm) in diameter for the 3-cm thruster. This reduction in the keeper-hole diameter is probably the best explanation for the increase in coupling voltage that was observed during the test.

Figure 18. Cross-section of neutralizer cathode orifice (dimensions in cm).

Since the neutralizer-cathode erosion was chiefly caused by low mercury flowrates, the obvious way to avoid the problem is to avoid operation at flowrates below 6 mA (equivalent). Periodic performance mapping, which includes neutralizer characteristics, can be made during a flight program to guard against this undesirable operation.<sup>6</sup> This will provide neutralizer keeper and coupling voltage as a function of mercury flowrate throughout the mission. Should the neutralizer-vaporizer flowrate (based on performance mapping) appear to be lower than 6 mA (equivalent), the neutralizer-keeper-voltage setpoint can be lowered to increase the flowrate to the appropriate value (i.e., 6 mA equivalent). Between the mappings, the neutralizer-vaporizer flowrate will be inferred from temperature readouts, and the coupling voltage will be monitored.

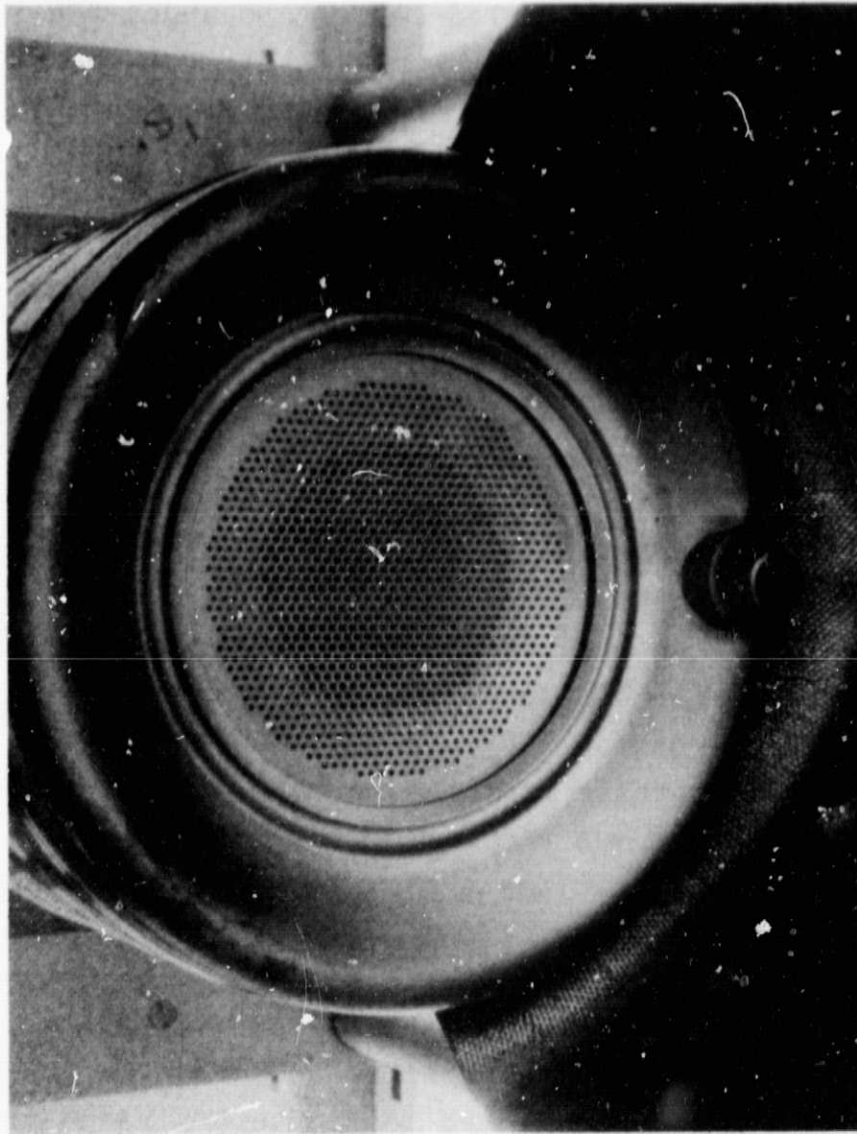
M14990

Figure E-5. Post-test appearance at accel grid.

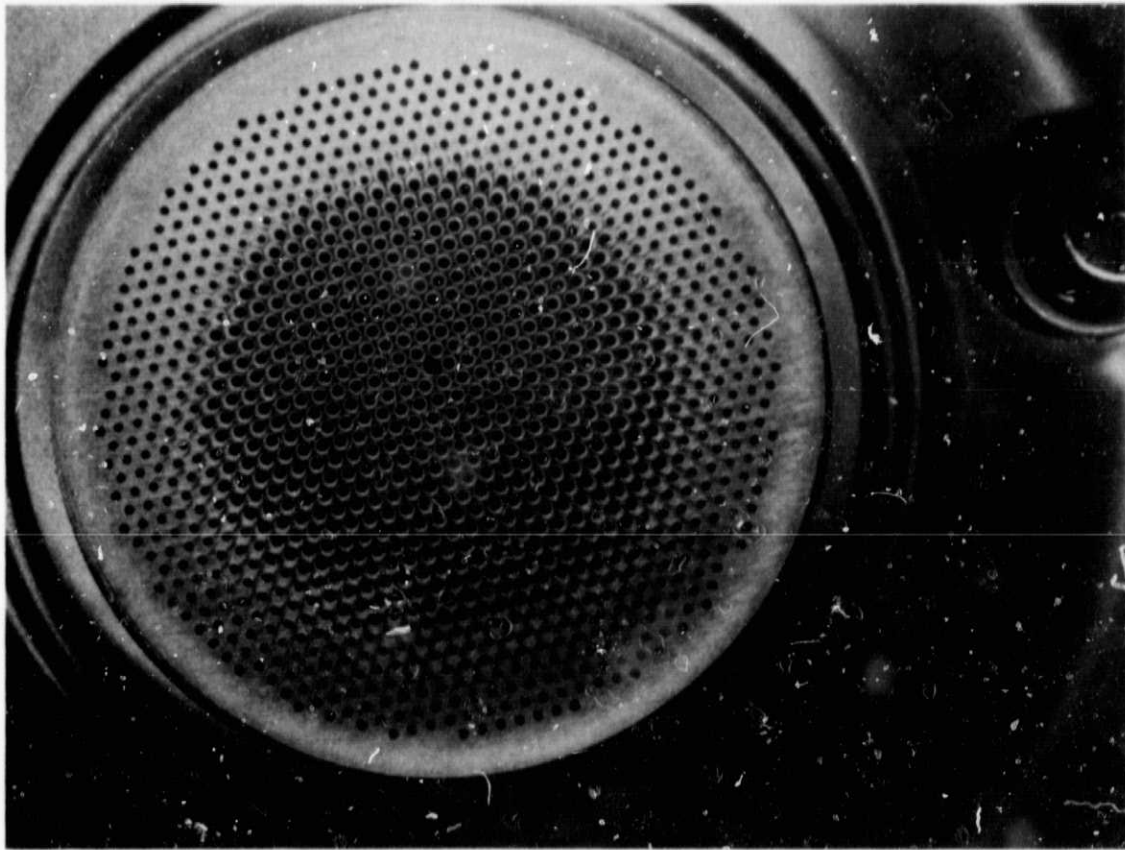
M14997

Figure E-6. Post-test appearance of accel grid (closeup).

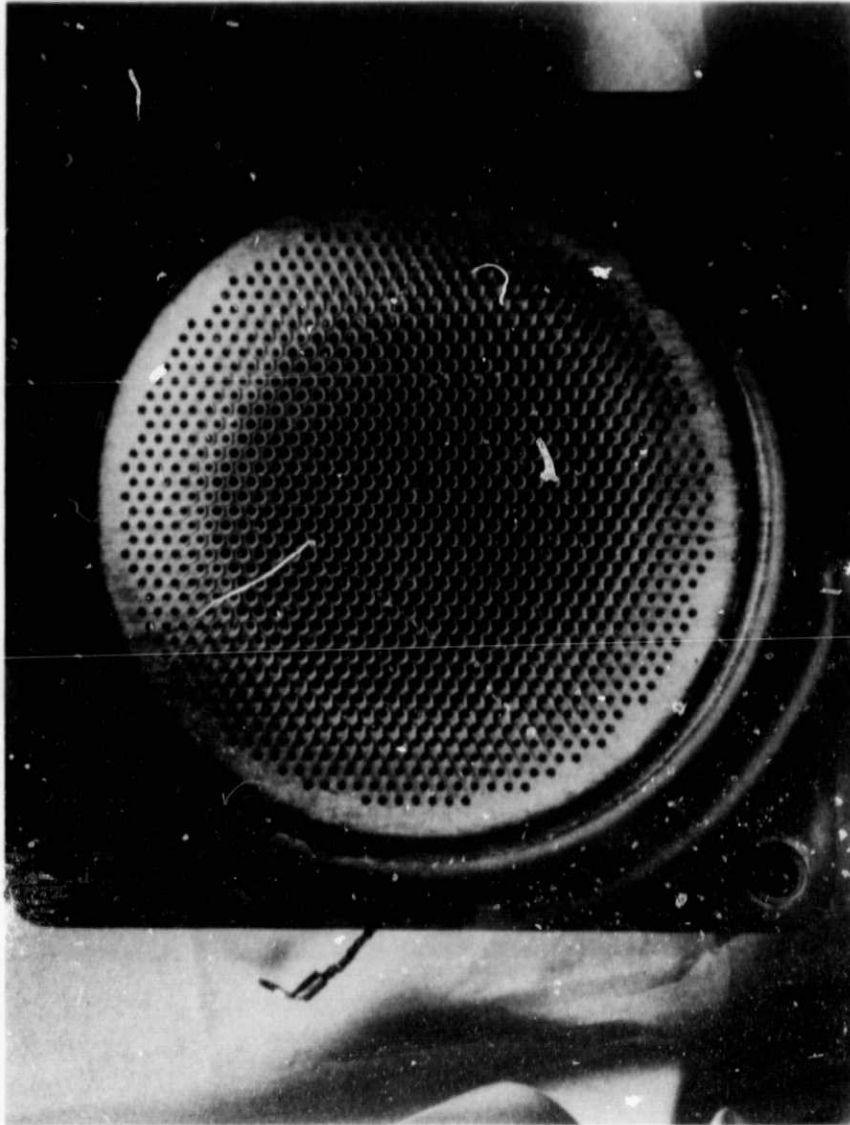
M14987

Figure E-7. Post-test appearance of accel  
grid after removal from thruster.

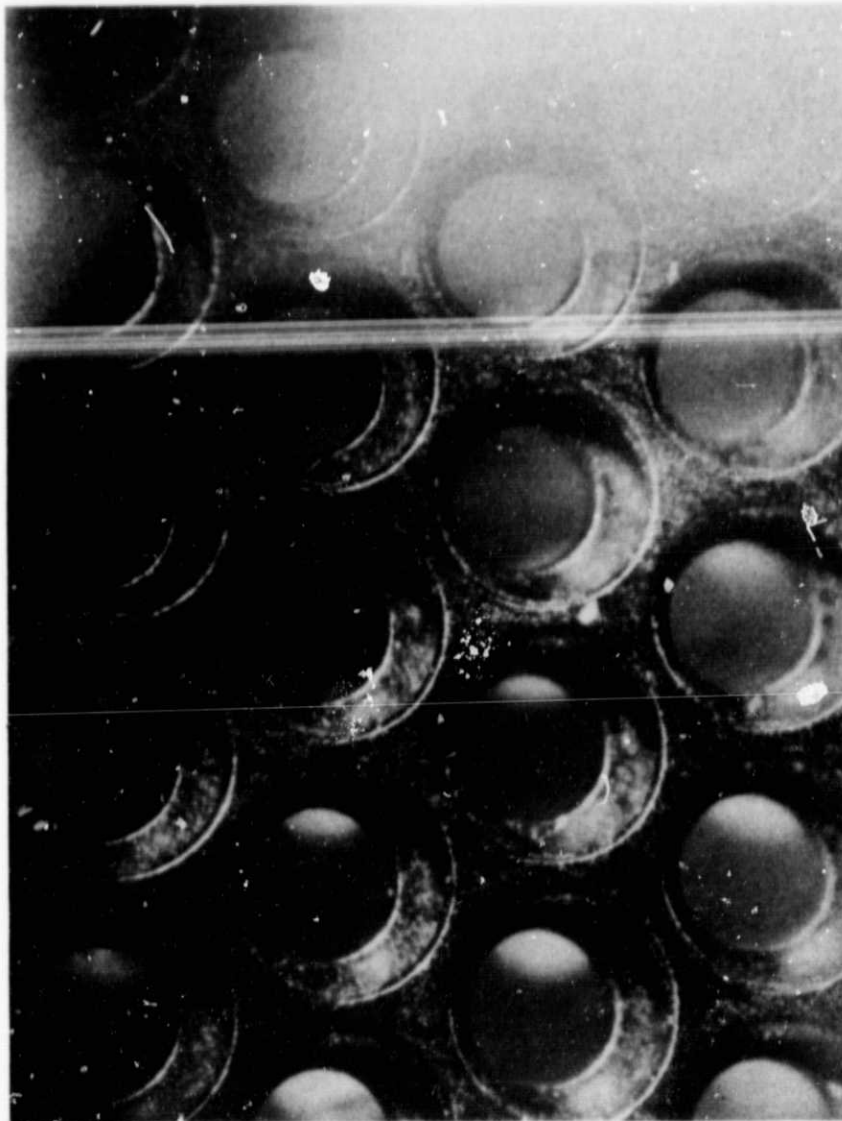
M15009

Figure E-15. Screen-side of ion-extraction assembly showing "crater".

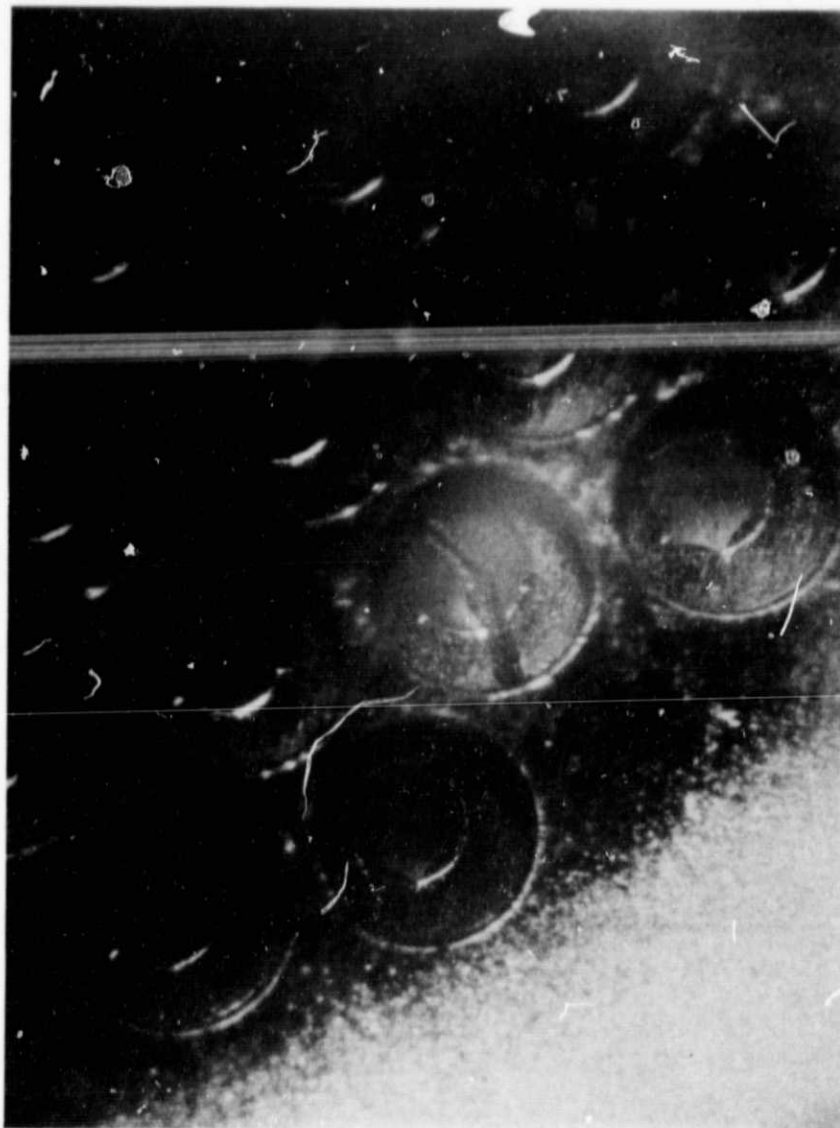
M15006

Figure E-16. Screen side of ion-extraction assembly showing accel notching.

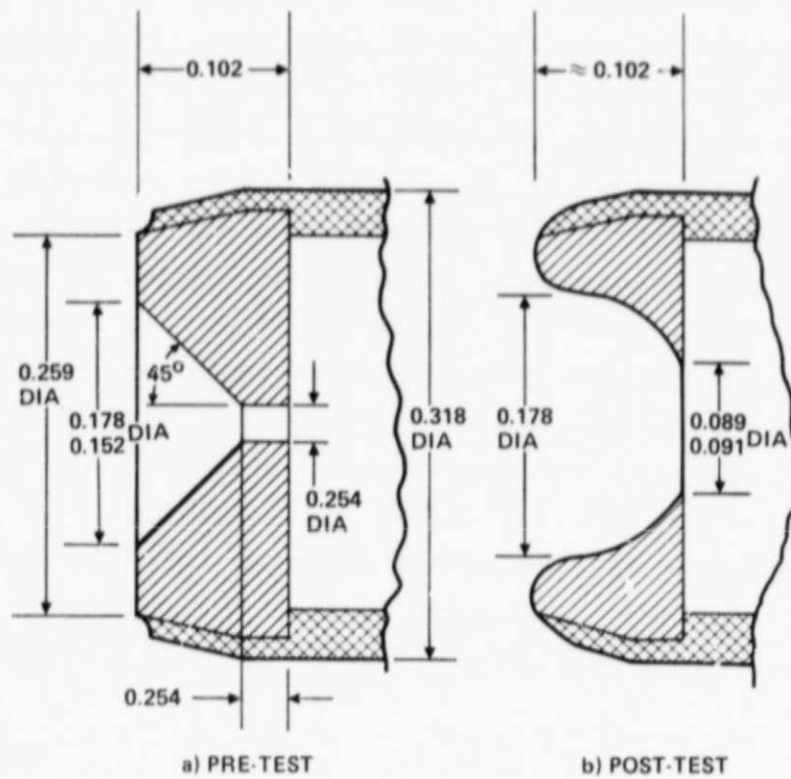
Figure E-34. Cross-section of neutralizer cathode orifice (dimensions in cm).

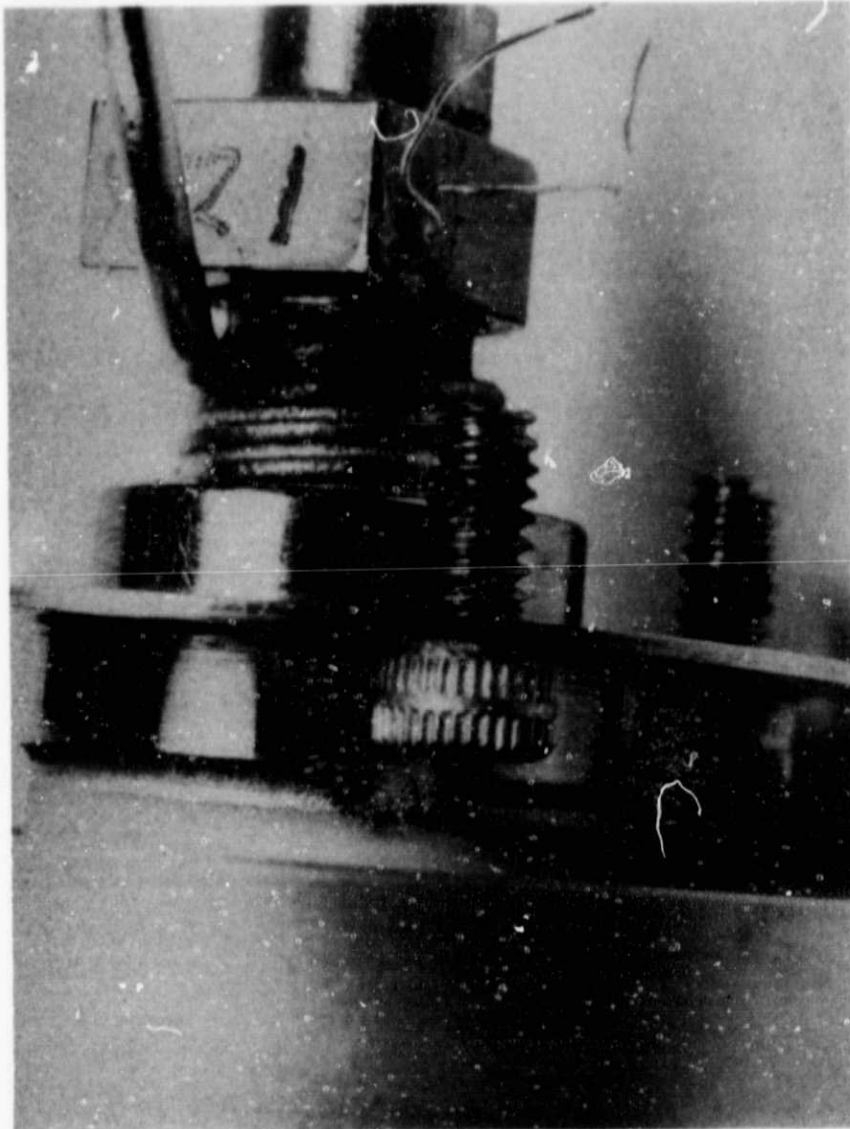
M15928

Figure E-41. C-I-V with ball of material on  
brazed joint.

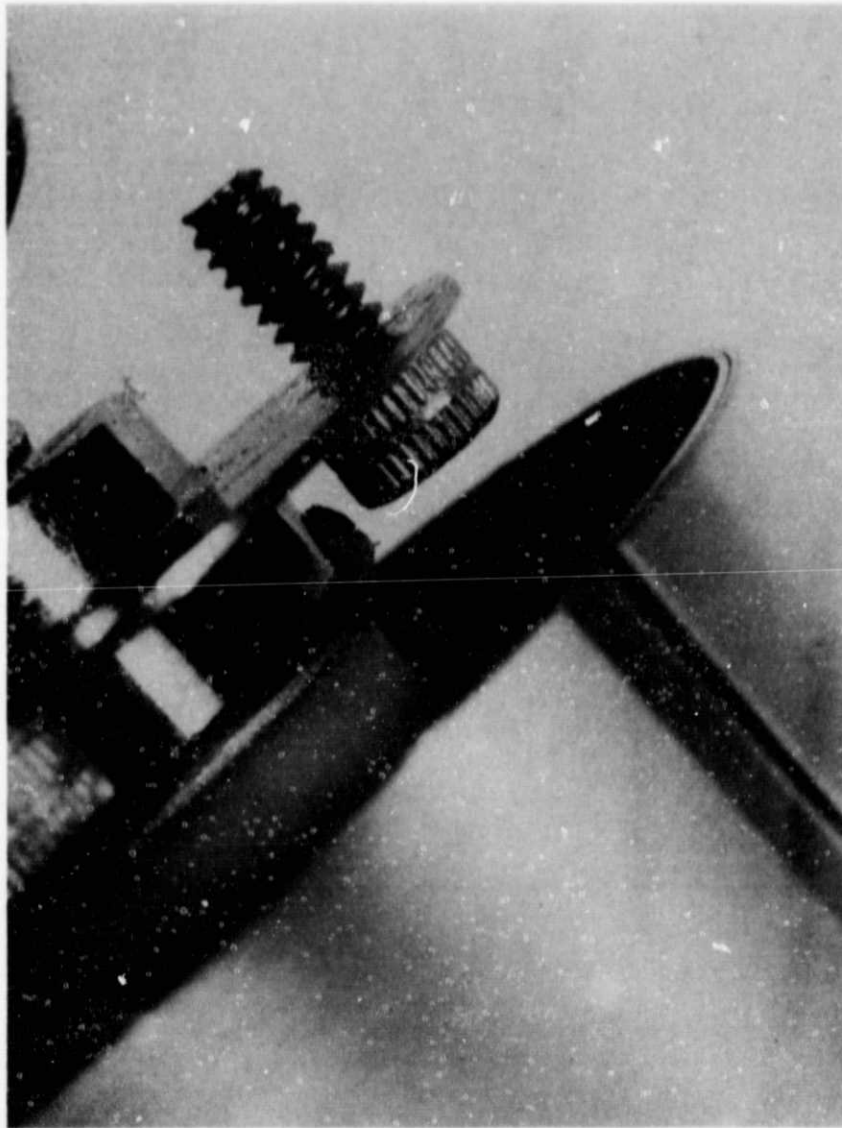
M15927

Figure E-42. C-I-V with ball of material  
on braze joint.

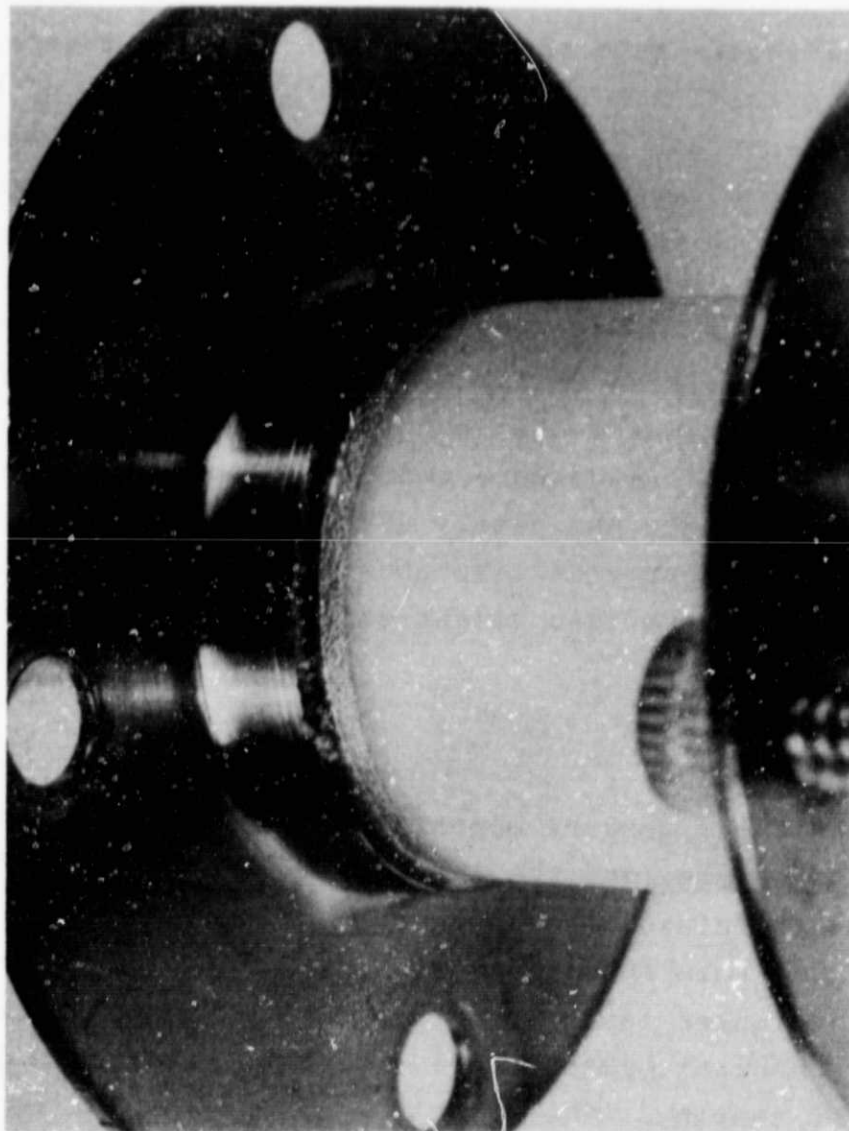
M15924

Figure E-43. Downstream isolator braze joint  
with foreign material.
